# PŘEHLED VÝZKUMŮ

| <i>Oto Makýš:</i><br>Construction of a Hypothetical “Celtic” Gate to a Sacred Area<br>in the Frame of the Archaeology Museum at Liptovská Mara | 119 |

Oto Makýš

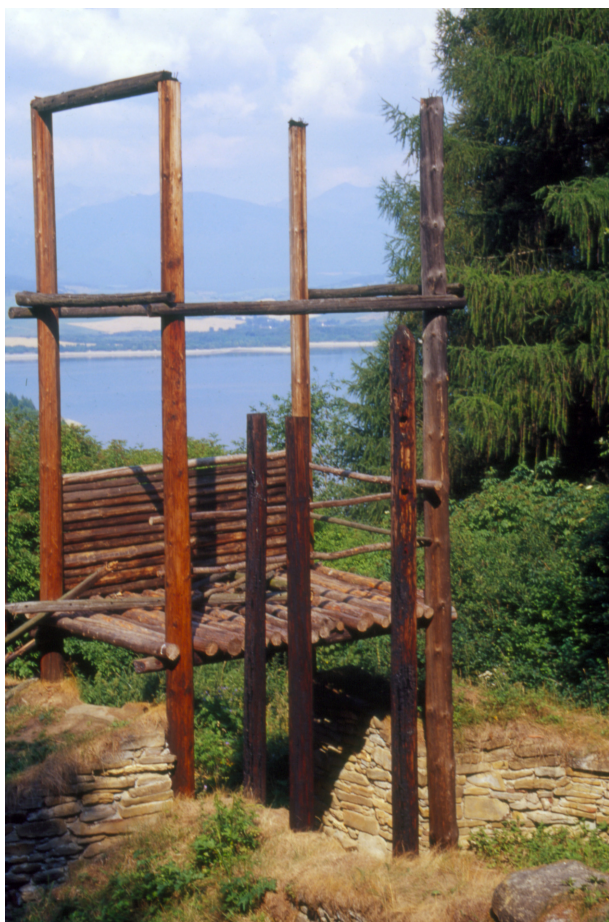
**Fig. 2.** Original state of the previous mock-up gate tower at the start of the reconstruction project in 2003.

**Obr. 2.** Pôvodný stav predchádzajúcej náznakovej prezentácie brány na začiatku rekonštrukčných prác.

The lack of appropriate maintenance showed on the tower construction with the decay of the pine post in the contact zone of ground-air and its general weakening. Part of the rungs was destroyed and rot (domestic Dry Rot Fungus / *Serpula Lacrymans*) had developed in most of the joints – caused by the collecting of rain water. The centres of the tops of the electric posts were also damaged – to about 0,3–0,5 m depth. The posts were cracked – some of the cracks reached nearly 2/5 of their diameter. After assessing the situation the mock-up tower building was rated as in a state of disrepair (Znalecký štandard 1993) with a rapid stabilisation necessary.

Because of the condition of the tower, it was necessary to dismantle the entire structure and joints with the exception of three of the load-bearing (originally industrially treated) posts which were decided to leave in their original positions. Thanks to the scale of the work it was decided to reassess the original building design. The project was (for its 2nd stage) therefore determined by two main view points – methodological and technical. A combination of both points of views brought many interesting problems which were to be solved.

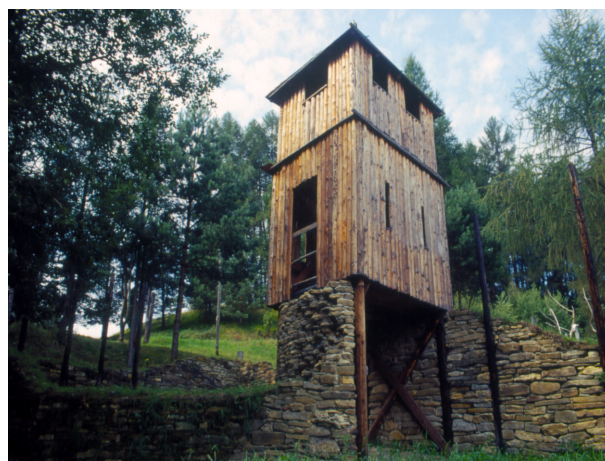
**Fig. 4.** Finished tower with a partly reconstructed stone masonry wall in its close surroundings in 2007.

**Obr. 4.** Hotová veža s čiastočne rekonštruovaným kamenným múrom v jej tesnej blízkosti v roku 2007.

the first—resistant as much as possible to weathering and vandals. Because of the scale of the damage to the current structure only three (in original electric, pressure impregnated) posts were left; the rest of the wooden construction was replaced with new elements. The left posts were repaired in the following fashion:

The biggest cracks and woodpeckers' holes were plated (with thin lamellas from the waste from other parts of the building of impregnated posts, glued with exterior adhesive Duvilax). The nests of decay at the joints with rungs was cleaned back to the healthy wood and plated like the cracks and woodpeckers' holes.

The rotting tops of the posts (centres) were cut off and replaced with new parts from impregnated wooden posts. They were joined by overlapping (to at least 0,5 m length) while the cut surfaces were at right angles on both sides. The joint were strengthened with exterior adhesive (Duvilax) and nails (at least 200 mm nails, hammered towards each other at angle of at least 30°).

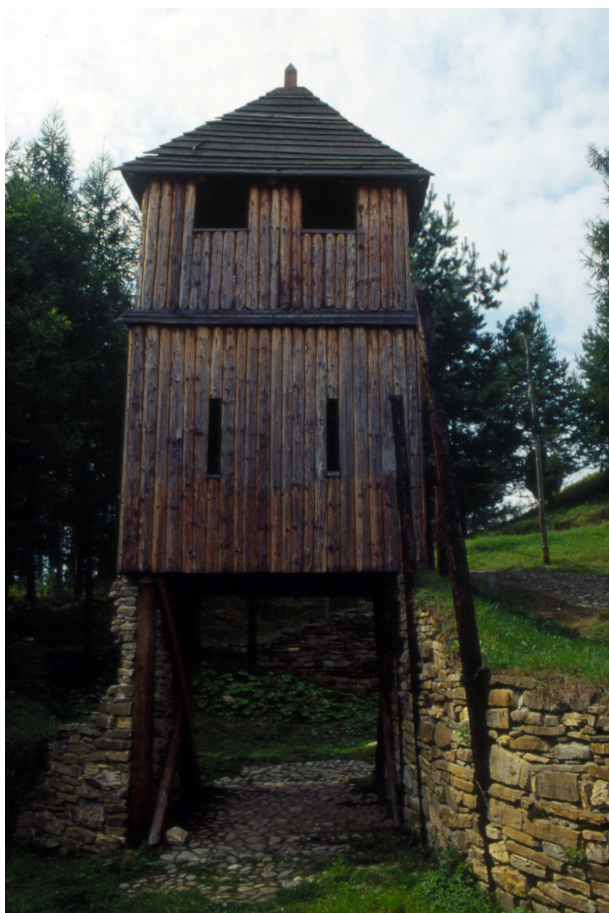
**Fig. 5.** Finished works on the wooden part of the gate tower to the sacred area – a look through the gate (2007).

**Obr. 5.** Hotová práca na drevenej časti vstupnej veže do posvätného obetiska – pohľad cez bránu (2007).

The main load-bearing construction (rough structure from vertical and horizontal elements) was built from industrially impregnated old electric posts, which show elsewhere at the grounds (in the same conditions) a very good state of preservation. The placing of wooden beams into constructions was done in a way to prevent water penetration into the structure, to allow its run off and dry out of the organic material as fast as possible. Even then it is not possible to prevent the wooden structures from getting wet, especially the posts, roof and the cladding.

The casing (roof, walls) and floor was done in such a way as to allow the dismantling and replacement of them in future (in a frame of needed maintenance) without the necessity to dismantle the main tower structure. At the same time they were made from cheaper wooden material (planks, split logs) so that the cost of their renewal was kept as low as possible. The parts exposed to weathering (especially the roof) were treated with chemical preservatives. The posts were placed in ground using concrete (this method has been shown in other parts of the area to increase the lifespan of the wooden posts) with stone collars at surface level to blend in with the surrounding cobbling. The structure was strengthened at every vertical and horizontal plane with triangle and cross ties. The joints were secured with nails.

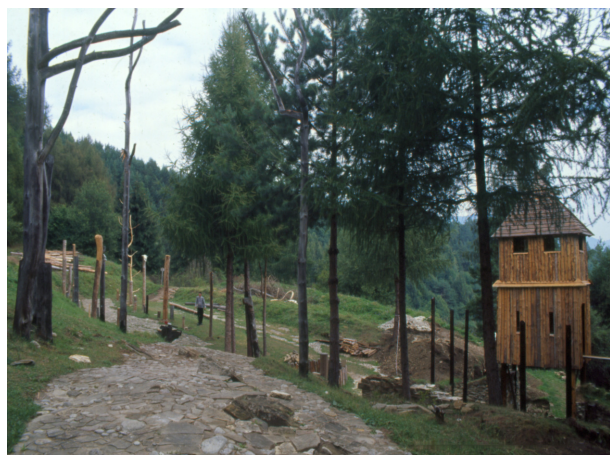
**Fig. 6.** Finished tower as a part of hypothetically the reconstructed sacred area—insight view from the inner area of the fortress (2007).

**Obr. 6.** Hotová veža ako súčasť hypoteticky rekonštruovaného posvätného obvodu obetiska – pohľad z vnútra hradiska (2007).

Regular maintenance (at least once a year – in the spring) means the clearing away of grass, self-seeded trees and the lowering of soil deposits along the wooden constructions. Regular airing of the inner rooms is very sufficient and therefore the tower is constructed in such a way, which allows fast natural drying out by airing. During maintenance it is also

necessary to pay attention to the condition of the roof and immediately repair any damage which would allow water penetration. It is also useful to check the building during strong or long lasting rains which reliably show any openings.
